CABARRUS COUNTY

PROJECT-AT-A-GLANCE

Replacing traditional bar screens at North Carolina Wastewater Treatment Plant improves employee safety and reduces maintenance.

EQUIPMENT: *Four (4) 4' x 47' FlexRake® FP-M w/ 1" Bar Opening*

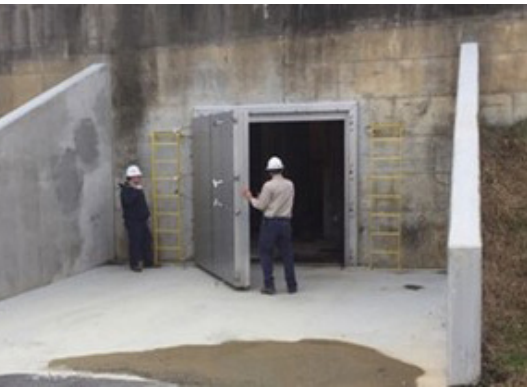
New intermediate access level door

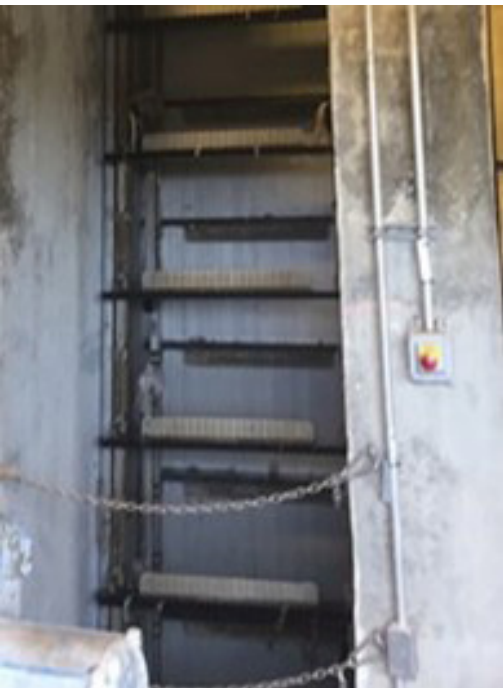
Main Pump Station intermediate level

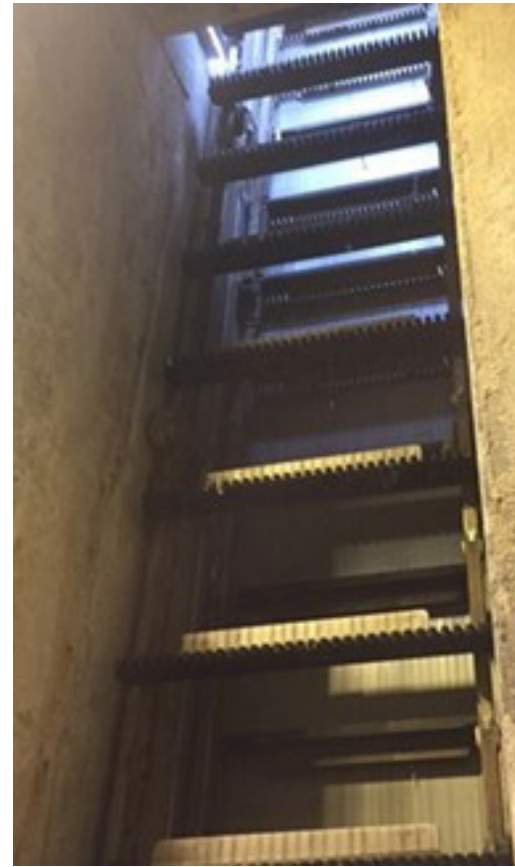
Main Pump Station intermediate level
